Metallic Whisker Sources

Access Floor Tiles Are Not The Only Source In the Mission Critical Environment.

By Worldwide Environmental Services

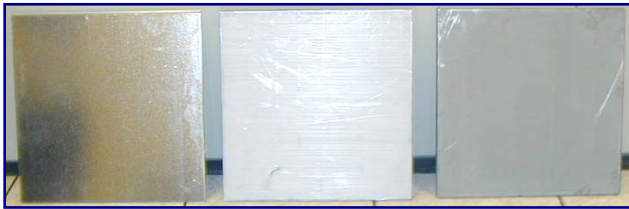
Pictured above are examples of three tile finishes. The spangled surface (left) and the light gray, streaked surface (middle) are both hot-dipped. The uniform dull gray surface (right) of the electroplate tile is also apparent.

There is a difference in the appearance of the various coatings used in floor tile manufacture. There are at least two variations of the hot-dipped process used in access floor tile manufacture. One produces a shiny surface with visible zinc crystals or spangles. This shiny, spangled appearance is often referred to within the industry as a "full G90 hot-dipped finish" and makes it easily identifiable. A second hot-dipped variation produces a streaked,

less shiny, light gray surface and is often called a satin finish. The electroplated process used in floor tile manufacture produces a more uniform and dull surface but scratches can cause shiny streaks as well. The satin finish hot-dipped tiles are often mistaken for electroplated tiles, which are the known threat. The reverse is also true with the electroplate tiles being mistaken for the satin finish hot-dipped tiles. An example of each type is pictured below.
